WIRELESS STATION A 510

TRANSMITTER AND RECEIVER REFERENCE: - Aust. Change in W.M. 13061.

PART A - SIDETONE

Issue 1, 31st November, 1956 RESTRICTED

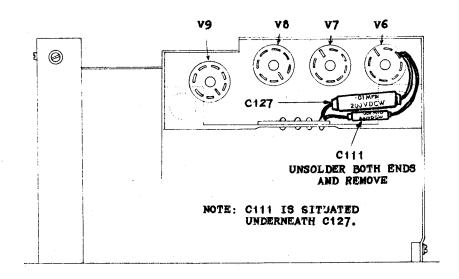
FIG. 2 SLEEVE BOTH ENDS AND SOLDER INTO PLACE 0 NOTE: C129 IS FITTED UNDERNEATH C127.

- 9. Remove C 111 and install C 129 in the following manner (see Fig. 2 and 3):-
 - (a) Unsolder and remove C 111 (0.005uF) which is connected from pin 2 of V6 to terminal plate and lies beneath C 127 (0.01uF).
 - (b) Place capacitor C 129 in space vacated by C 111 and cut leads to required length.
 - (c) Sleeve the pigtails with yellow $1\frac{1}{2}MM$ PVC sleeving and solder one lead to pin 3 of V6 and one to the earthed spigot of V7.

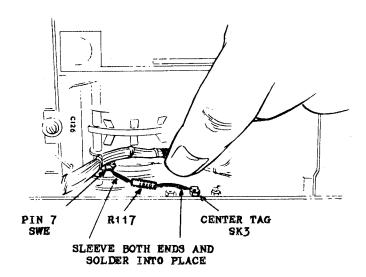
FIG. 4

- 3 FIG.
- Install R 117 in the following manner (see Fig. 4):-10.
 - (a) Unsolder and remove lead from centre tag of SK3 to pin 7 of switch SWE.
 - (b) Solder R 117 (220,000 ohms ½W) in position formerly occupied by removed lead.
- Strike out No "1" on the transmitter and receiver modification plate. 11.
- 12. Replace transmitter and receiver in cases.
- Check side tone oscillator keying speed and general function of transmitter. 13.

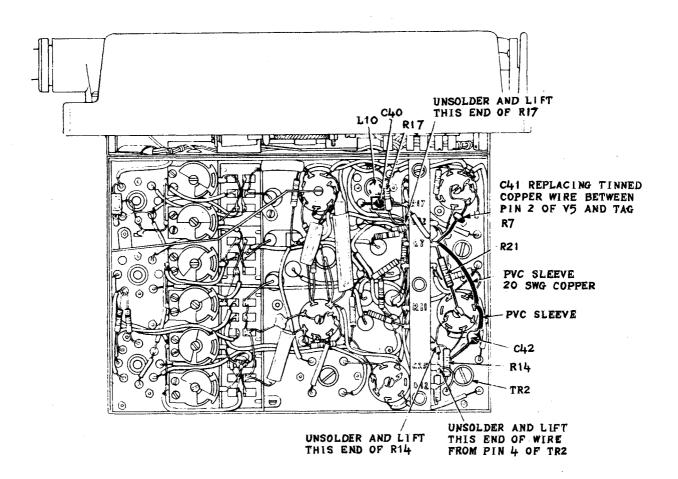
FIG. 1

- 6. Remove receiver chassis from case and install the following as detailed (refer Fig. 1).
- 7. C40 -
 - (a) Unsolder and lift end of R17 (47,000 ohms ½W) connected to tag marked C32.
 - (b) Cover body of C40 with 3/8 in. of 10MM. PVC sleeving and solder into place, connecting between pin 1 (green spot) of L10 and the tag marked R17.
 - (c) Solder floating end of R17 back to tag marked C32.
